Thank you for purchasing the PG-FP5 flash memory programmer.

This document describes specifications that have been added or changed, restrictions, and cautions on using the PG-FP5. Also see the user's manual of the PG-FP5 for terminology and points for caution on using the PG-FP5.

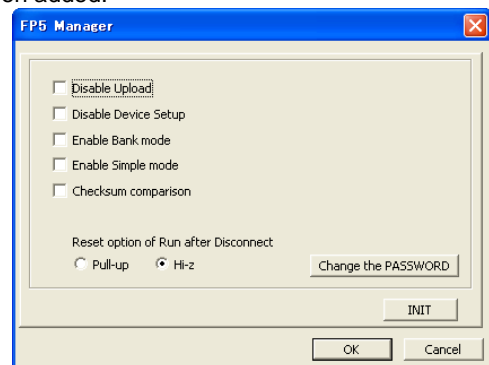
Description: The following FP5 Manager functions have been added.

- Password function
- Upload disable function
- Device setup disable function
- Bank mode enable function
- Simple mode enable function
- Checksum compare function
- Reset pin characteristics switch function

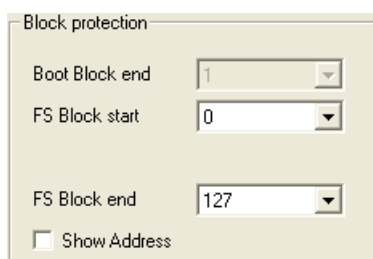
Before change

Description: The layout in the **Block protection** area has been changed.
